December 2006

Lands End Groin Study

Sea Pines Resort

Hilton Head Island, South Carolina

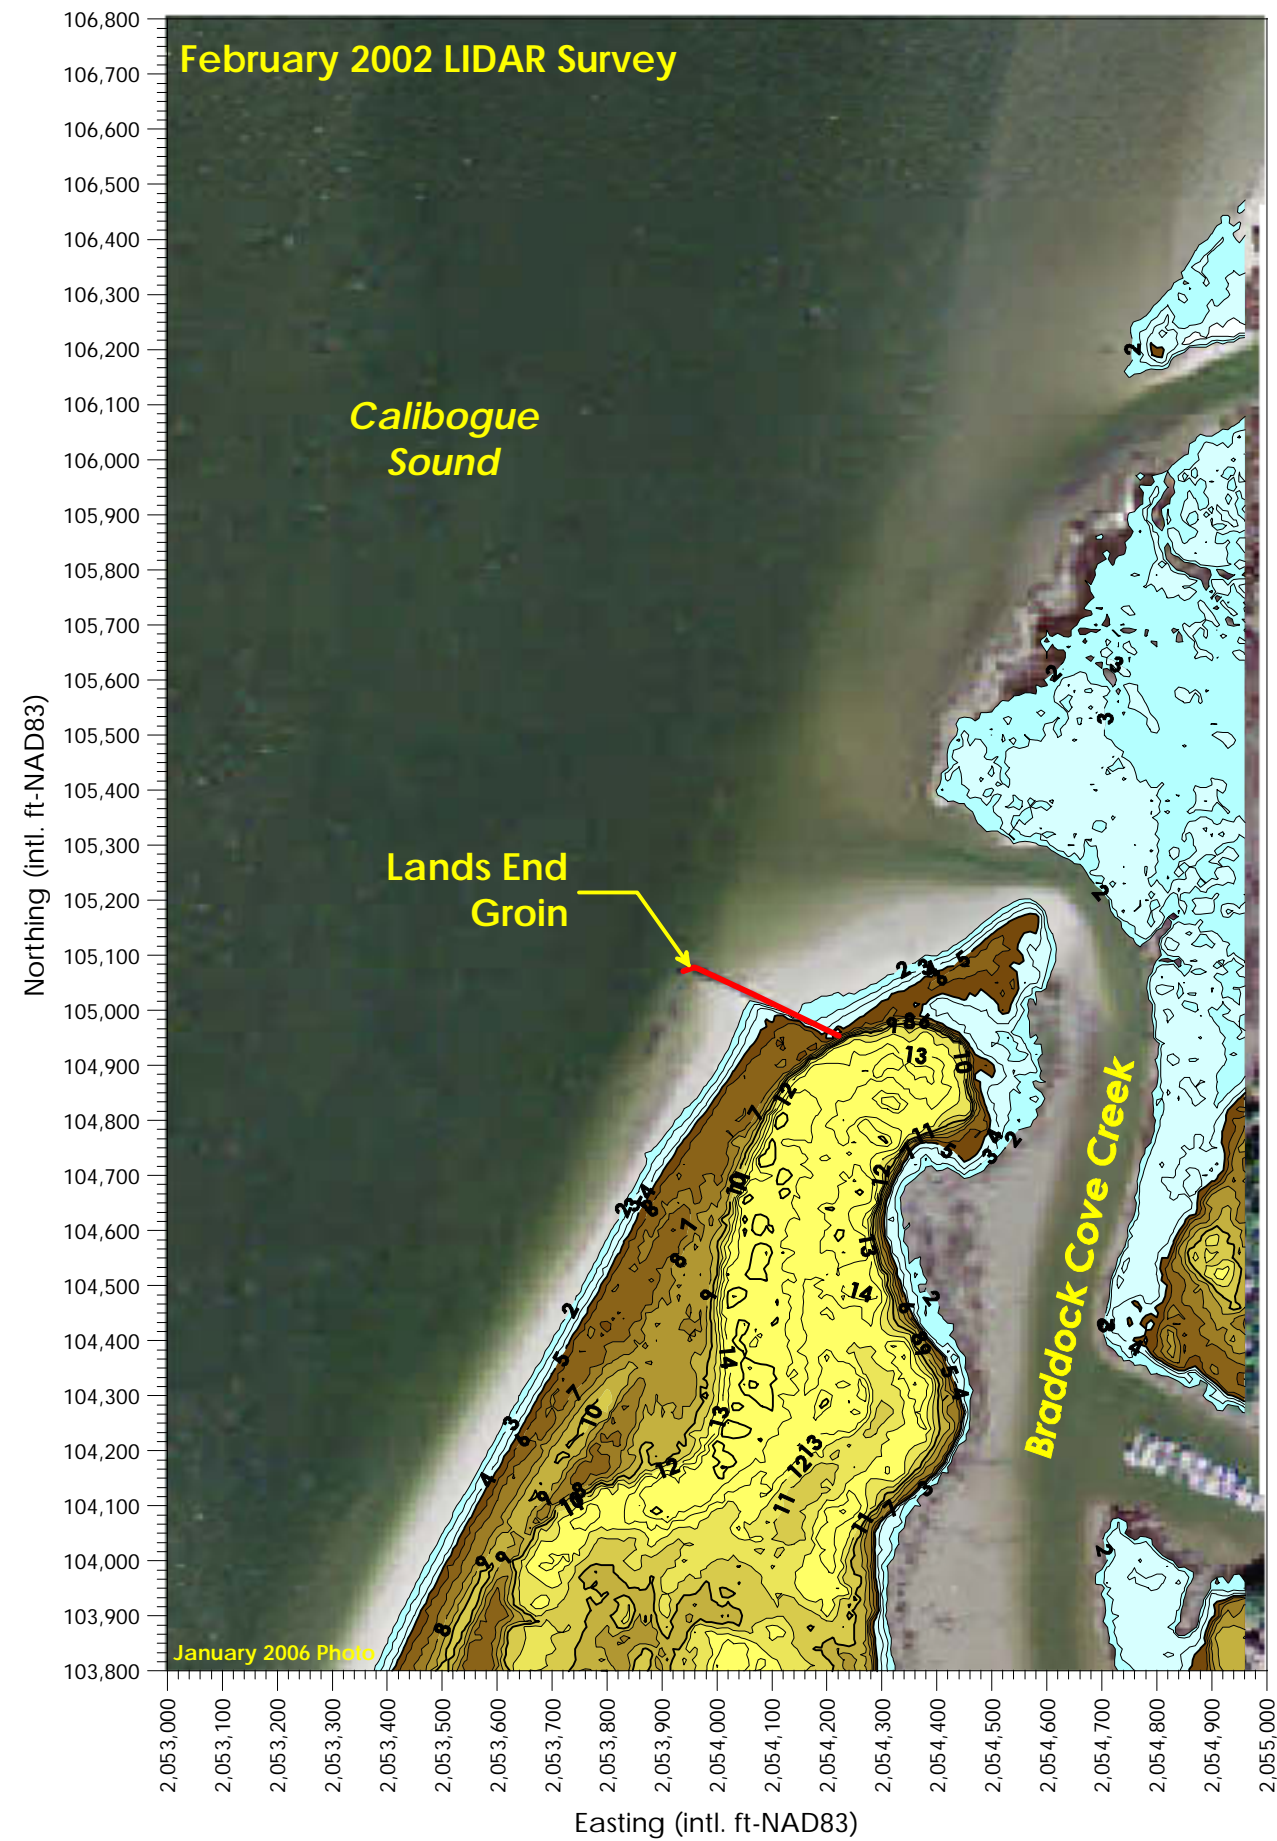
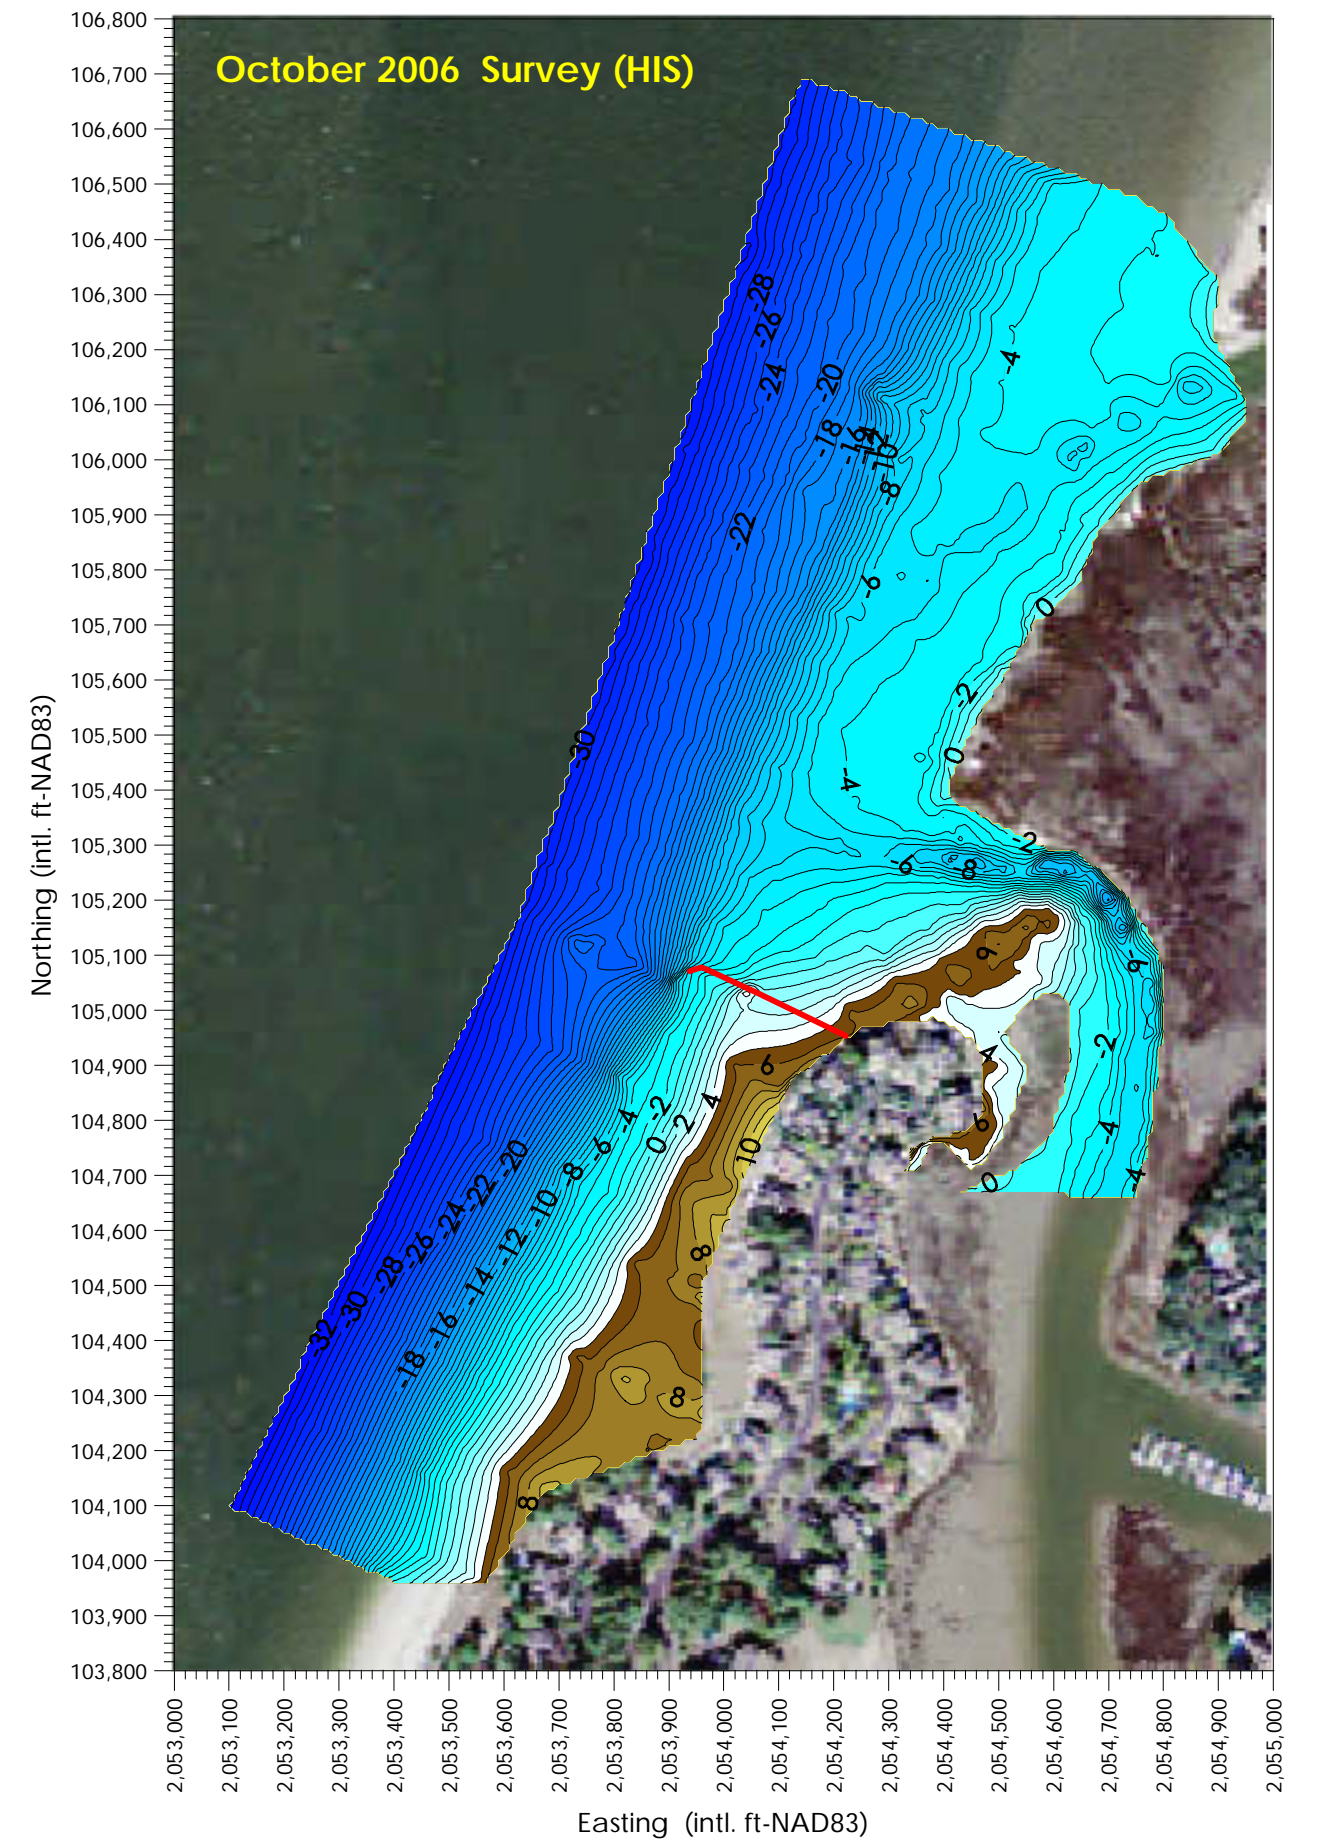
Figure 3.2: February 2002 and October 2006 surveys at the Lands End Groin.

In the roughly 30 years since the groin was constructed, the structure has deteriorated to the point that it is no longer functioning as originally intended. Anecdotal information obtained through this investigation from Community Services Associates (CSA) suggests that some timbers and chocks were replaced in 2002-03. However, this action does not appear to have significantly altered the function of the structure. As of 2006, several of the wooden chocks are damaged or missing, resulting in the vertical movement of spanning timbers during the tide cycle (**Photo 3.2**). The groin is not sand-tight and therefore is not a highly effective sand retention structure (**Photo 3.3**). Evidence of the porous nature of the structure is the large sand spit along the southern bank of the Braddock Cove Creek entrance (Photo 2.1). However, even if the groin was made sand-tight to the original design elevation¹, sand transport over the structure would continue during storms and elevated tidal conditions. In Figure 3.1, a beach profile located approximately 135 ft south of the structure is plotted along with the presumed design elevation of the structure. Note that along the upland portion of the beach (above +4 ft), the Oct. 2006 surveyed beach profile is typically 0 to 5 feet above the original design elevation of the groin.

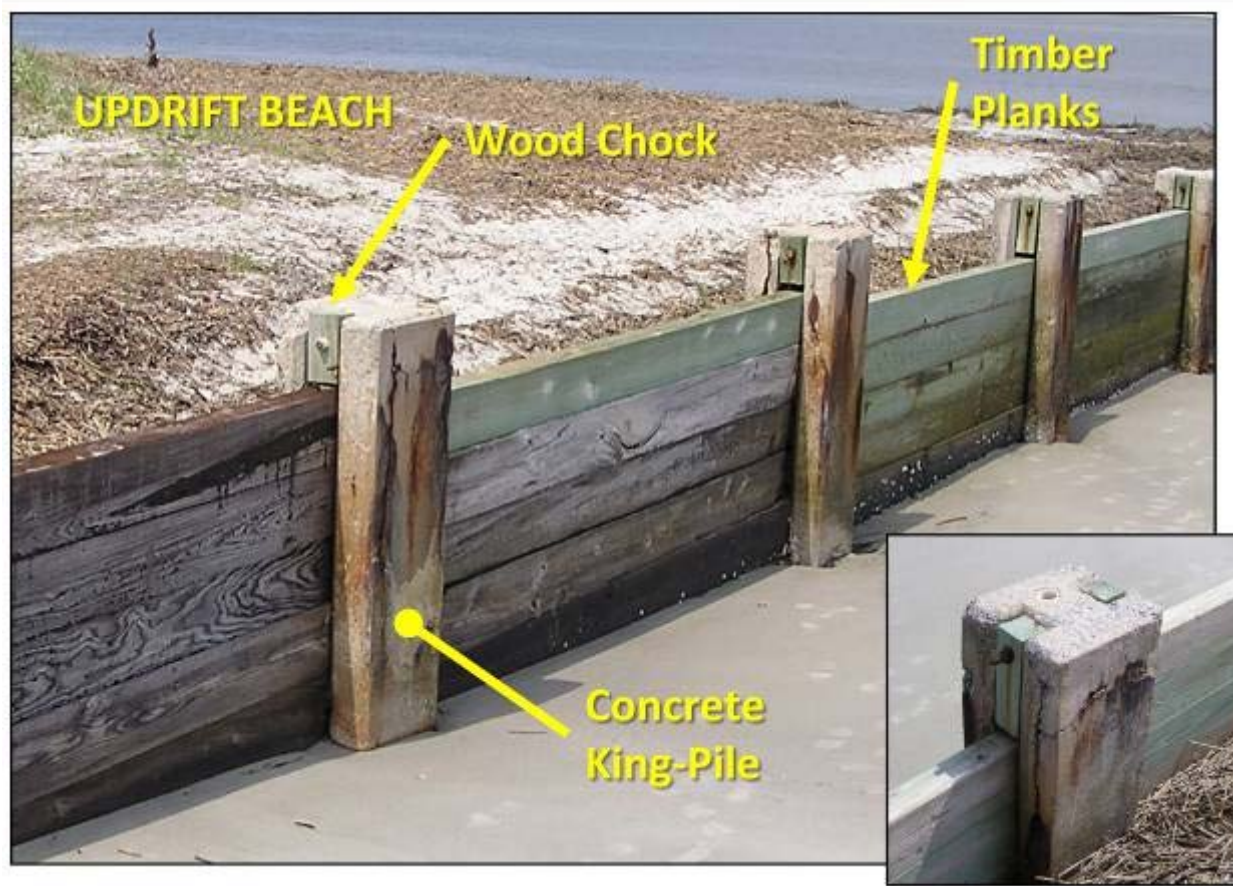
Photo 3.1: Photo showing intact pile/timber/chock structures

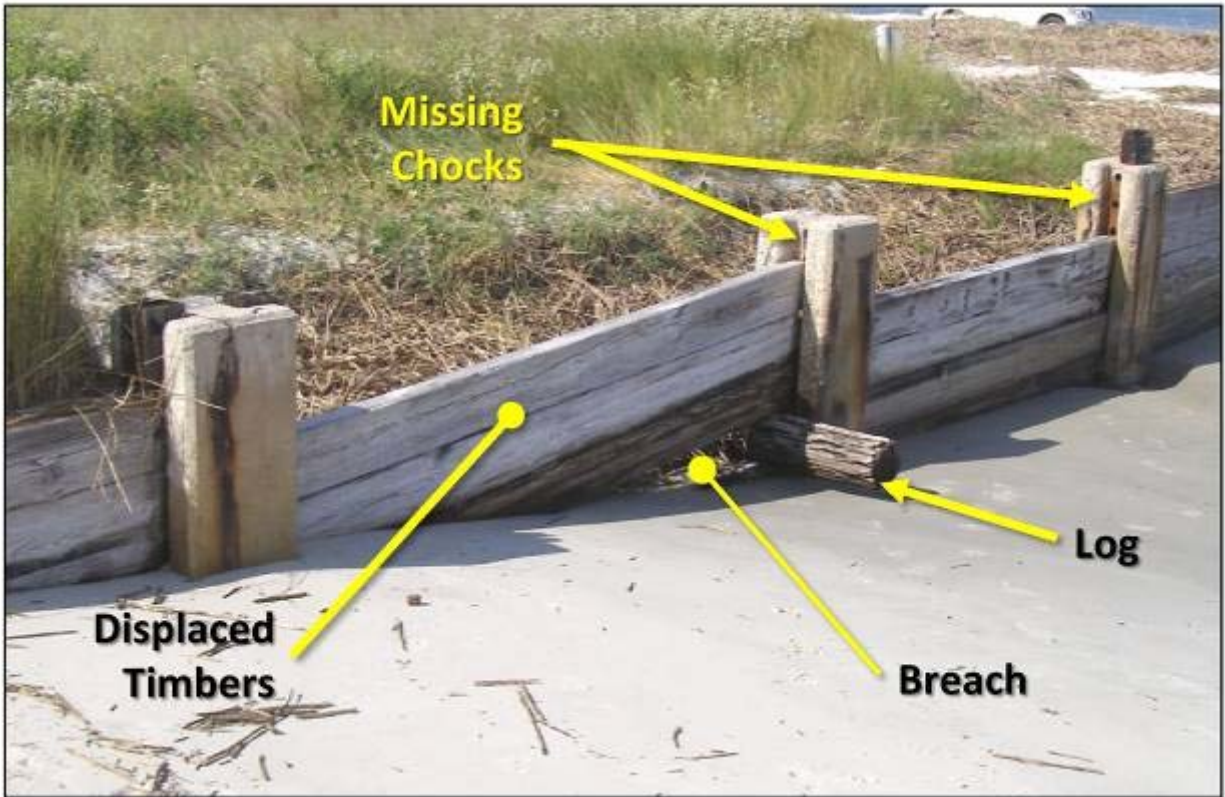
Photo 3.2: Photo (Sept. 2006) showing damaged pile/timber/chock structures and resulting breach.

The restoration of the groin to its original design condition would require that all damaged timber panels be replaced. The new panels would need to be locked in place with new chocks. Chocks are wood blocks which are thru-bolted to the top of the king piles for the

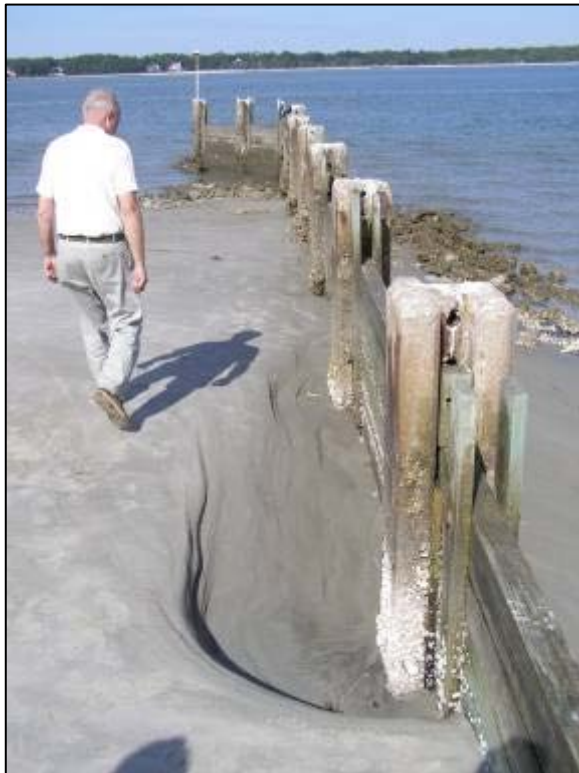
Photo 3.3: Scour hole formation resulting from sand and water movement through the structure. Note: Photo taken at low tide conditions (Sept, 2006).

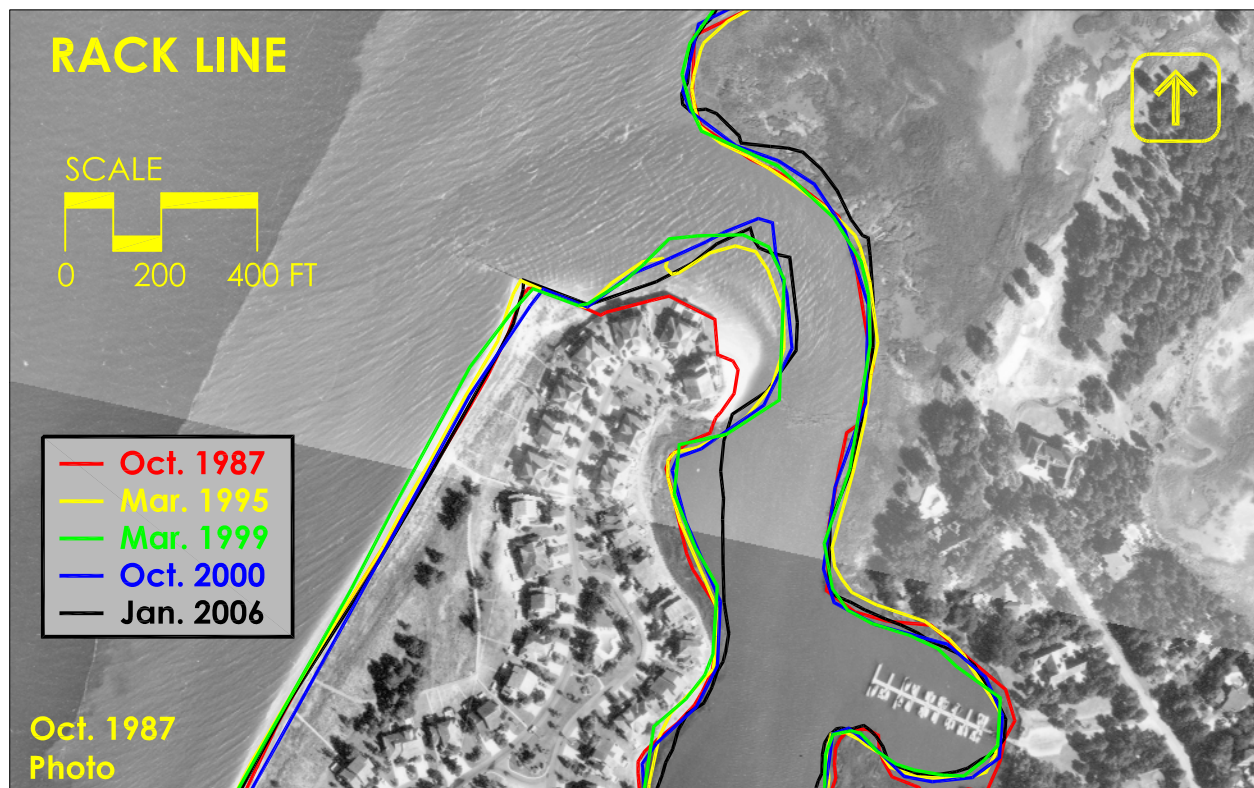
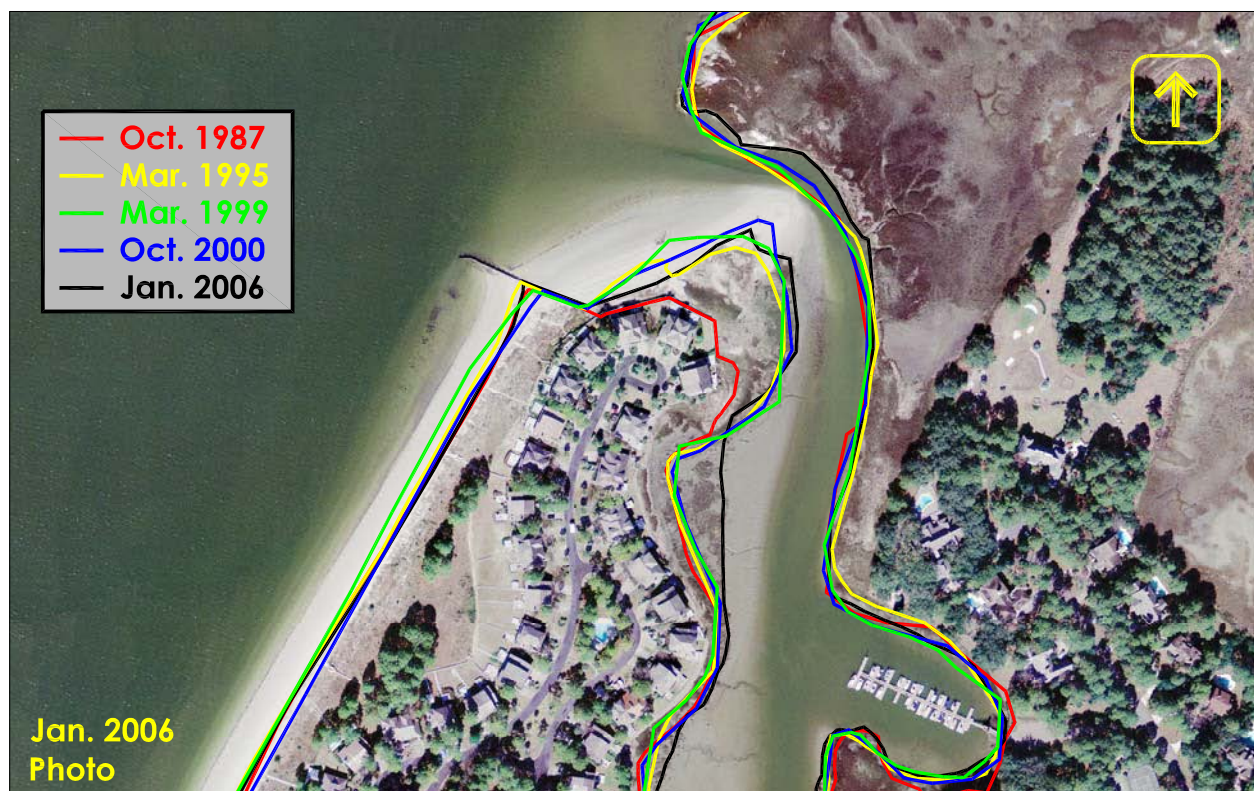
Figure 4.6 summarizes the historical changes in the “wrack” line north of the Land End groin between 1987 and 2006. Comparison of the wrack line delineations demonstrates that the most pronounced change in the size of the spit north of the groin occurred between about 1987 and 1995. Subsequent to 1995, changes in the size of the spit are also evident but the rate of spit growth is reduced significantly compared to that which existed between 1987 and 1995. The continued but slower growth of the spit after 1995 suggests that (1) sand continues to be transported across the Land End groin from south to north and (2) the entrance channel to Braddock Cove may have reached its minimum equilibrium configuration. That is, the tidal flows in and out of the channel are sufficient to maintain a minimum channel area (sf) under the forces of sand accumulation from the adjacent shoreline.

In this configuration, it is expected that size of the spit and the channel are controlled by the tidal scouring and sand that is transported across the groin is distributed across a growing ebb tidal shoal of Braddock Cove Creek. This may explain the present day shallow controlling depths typifying the platform located beyond the narrowest section of the channel and Calibogue Sound. Accordingly, it is likely that the continued transport of sand across the Lands End groin may result in additional sand accumulation across the ebb tidal shoal area of the creek and therefore more restrictive navigable depths. Due to the size of the Braddock Cove lagoon and relatively low sand transport rate to the inlet, it is unlikely that the Braddock Cove entrance channel would close completely, unless a significant storm event impacts the area and transports material from the spit into the controlling area of the channel at a high rate.

Figure 4.6: Digitized **RACK LINE** position for the Lands End groin area (1987 to 2006)
